RESIDUAL STRESS RELIEF ANALYSIS ON LOW CARBON STEEL RINGS

Daniel Lopez Gomez
Linköping's University
5/21/2013

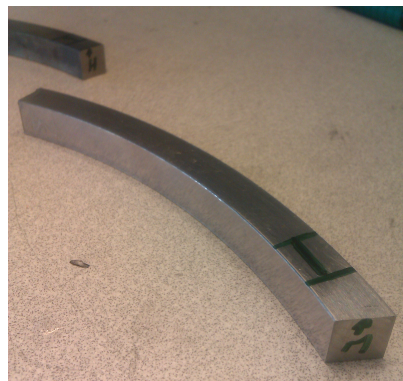
Figure 2.2 Cuts performed to the rings in order to obtain the specimens

Three specimens will be created. Each one will have both radial and tangential surfaces. In order to differentiate them, a green mark will be added to the radial piece of the ring. The middle surface in between the pieces coincides with the red and green lines explained above. Once the specimens are created, they will look like the picture below.

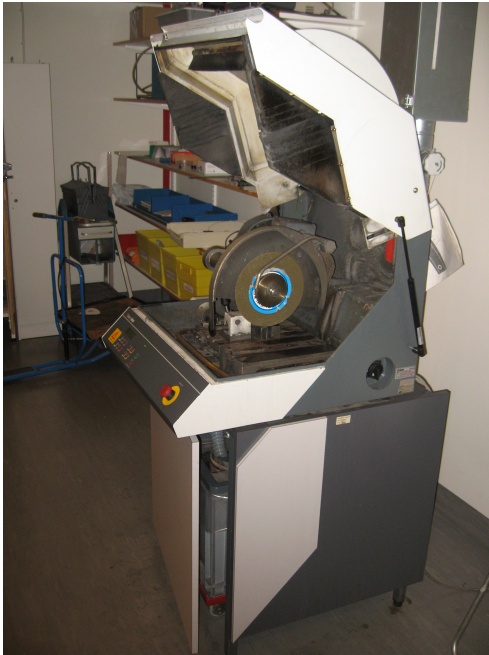
The first cut was carried out by the machine shown in the picture below. It provokes a quite big mechanical deformation within the ring so this machine will be appropriate just for the first approximation based on the cut of a small piece out of the whole ring.

Figure 2.6 Big cutting machine

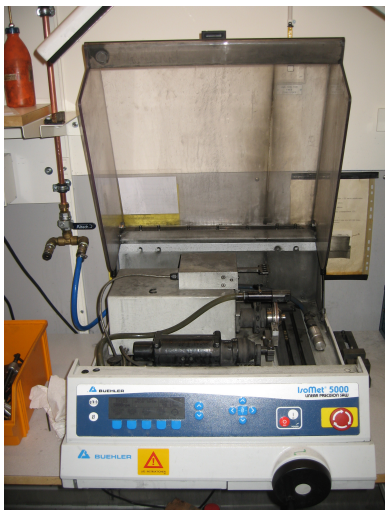
For higher approximations, a second cutting machine will be used. Once a small piece is obtained, the next step will be executed with this second cutting machine named above and shown in the picture below. This one will be a more precise cut and the final one.

Figure 2.8 Small cutting machine (1)

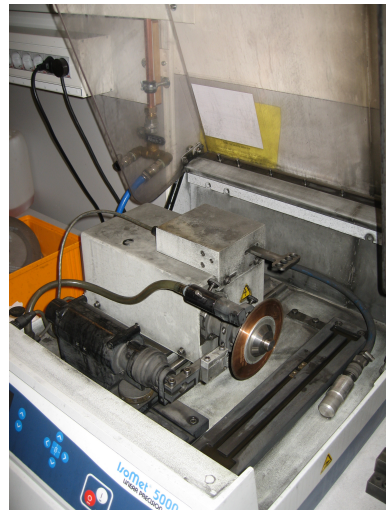
Figure 2.9 Small cutting machine (2)

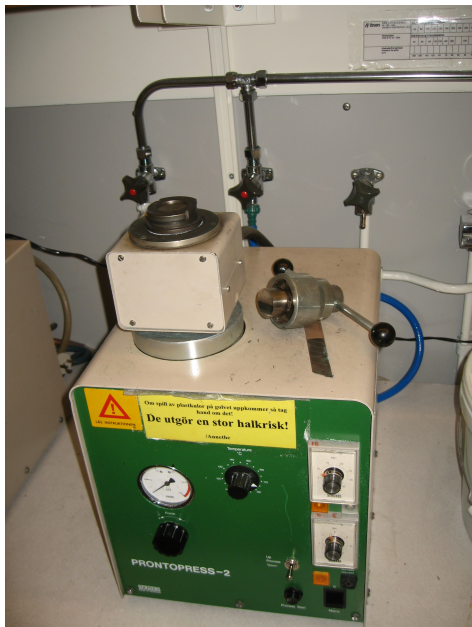
The cut pieces of the ring will be introduced in a machine (see picture 2.10). The surface of interest will lie against the cylinder base of the machine and once the ring pieces are set, the cylinder will be sent inside the machine and 4 cups of the resin powder will be added in order to create a cylinder. Just after the resin is inserted, the cover is set and the process is started. The metal pieces and the resin will be heated and exposed to a 10 MPa pressure. The process of melting the resin will last 7 minutes and right after, the specimen will be rapidly cooled for three minutes.

Figure 2.10 Mounting machine

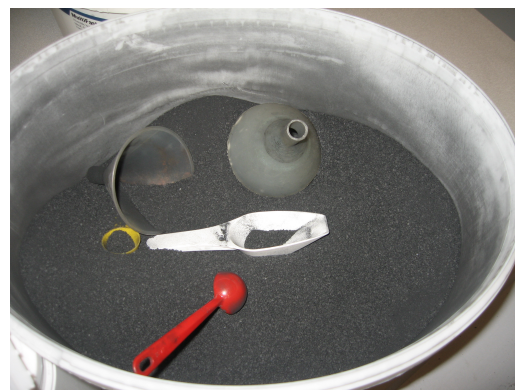
The mix selected to create the cylinder depends on the use of the specimen. As both light and electron microscopes will be used to analyse the microstructure, a special mix of phenolic hot mounting resin with carbon filler will be selected. The black resin allows electricity go through the specimen in the electron microscope. Also the utilization of an etchant to reveal the microstructure will influence the type of mix used for the mounting ^[7].

Figure 2.11 Mounting resin

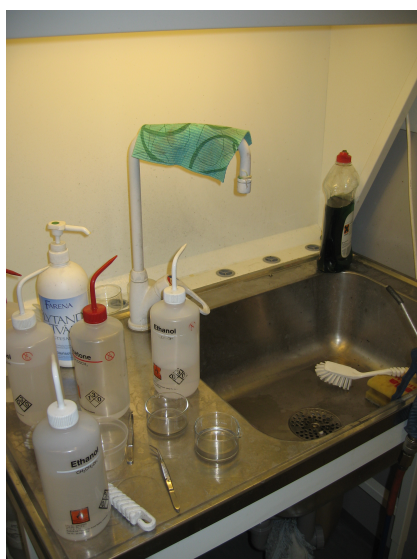
Figure 2.14 Cleaning sink

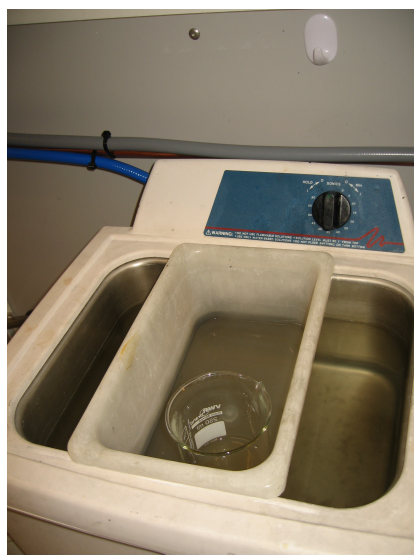
The specimens are introduced in a glass filled with alcohol and put in the ultrasounds machine (see picture 2.15). For around 30 seconds, the ultrasonic waves remove the impurities of each specimen.

Figure 2.15 Ultrasonic machine

However, when finer polishing is to be achieved, it is necessary to clean the specimens with an ultrasonic machine. This device uses ultrasounds (between 20 and 400 Hz) and a cleaning solvent. This procedure is based on an ultrasonic generator that creates ultrasonic waves in the fluid. The cavitation phenomenon is produced by these waves. Millions of bubbles are generated in the fluid and when they go across the surface and holes of the material, the surface is cleaned. The higher frequency is, the deeper and exigent the cleaning is [8][9].

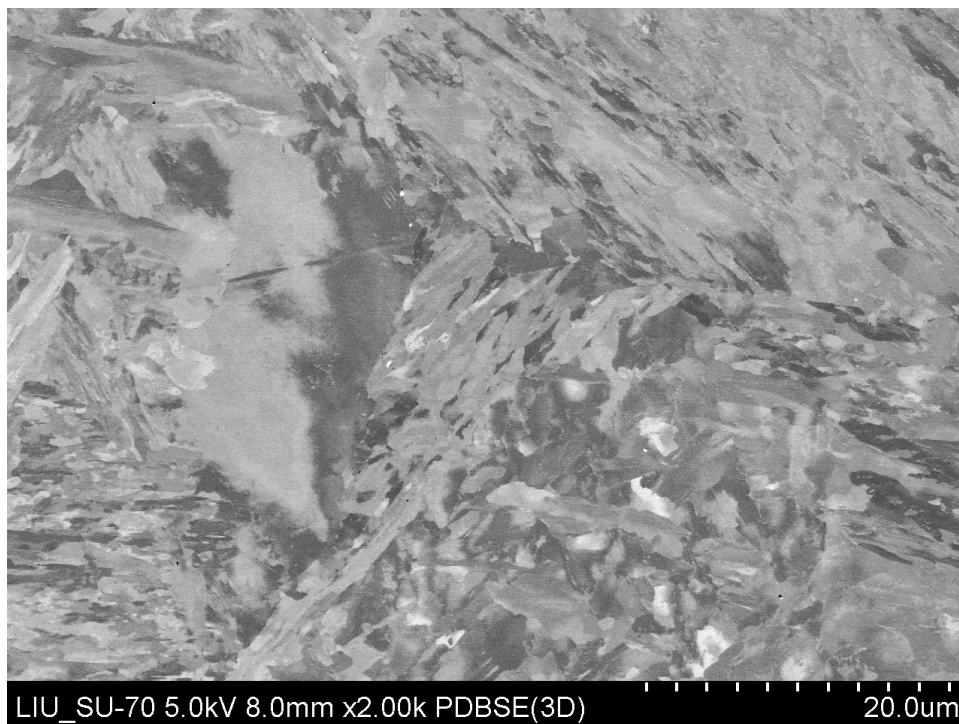
Some pictures captured the core of the VSR specimen in order to analyze the microstructure. Same conclusion was carried out, lath martensite and ferrite were found. They are displayed in figures 3.55 to 3.57.

Figure 3.56 Picture of the inside of the VSR specimen in tangential direction, 2K magnifications (2)

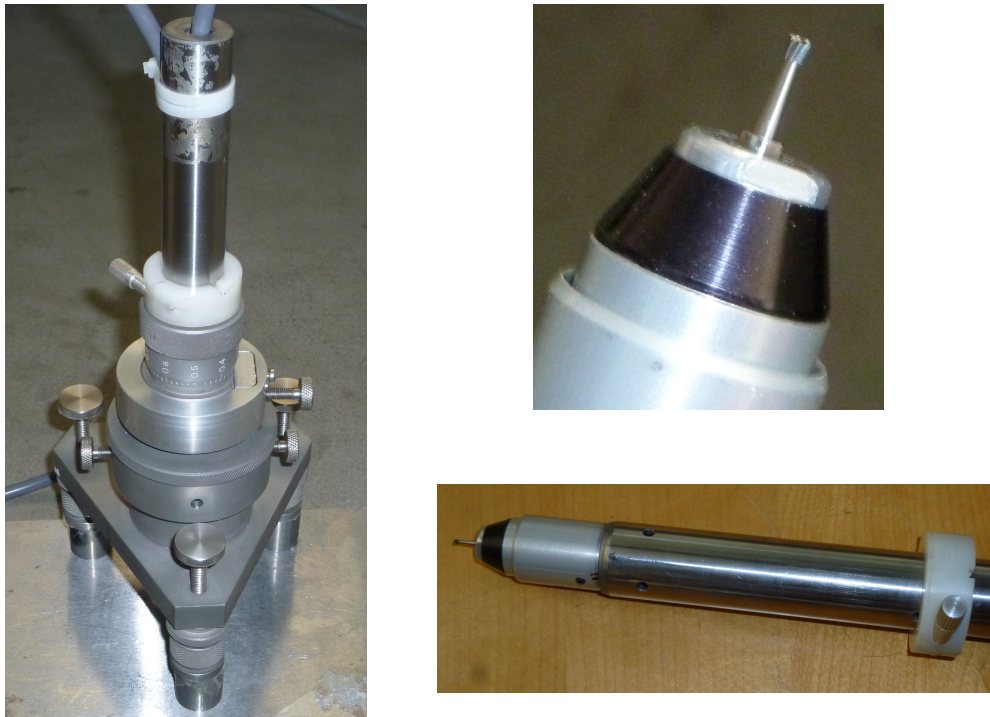
Once the ring is placed in the right position, the microscope is replaced by the drilling machine, shown in figure 6.1. Helped by a micrometre, the drill starts going down. It is a manual process and it has to be stopped once the drill touches the strain gauge's surface. In that very moment, the value recording machine is settled as zero and the drilling process starts. The method used for drilling is the one which, while the drill goes deeper by turning the micrometre around, the drill has to be turned as well, 185° in this case. The drilling process is very simple. The first millimetre is the depth of interest as the greater changes take place in it. As a consequence, the depth drilled each time will be 40µm. The procedure is to turn the micrometre around as the same time that the drill is also turned around 185°. Each time a new depth is carried out, the drilling turn will change directions. After each drill, a couple of minutes have to be waited until the strain values get stable. The reason is that, while drilling, some friction appears and, as a consequence, the strain gauge is heated up and the value cannot be trusted. Once the value shows constant in the machine, it is filed and the next depth could be carried out. Once a flat tendency is noticed in the values output, the drilling could be stopped.

Figure 6.2. Drilling machine and details of the drill
